Land Subsidence Rate in the Fort Grant Rd and Willcox Areas, Cochise and Graham Counties
Based on Radarsat-2 Satellite Interferometric Synthetic Aperture Radar (InSAR) Data
Time Period of Analysis: 1.0 Years 04/12/2019 To 04/30/2020

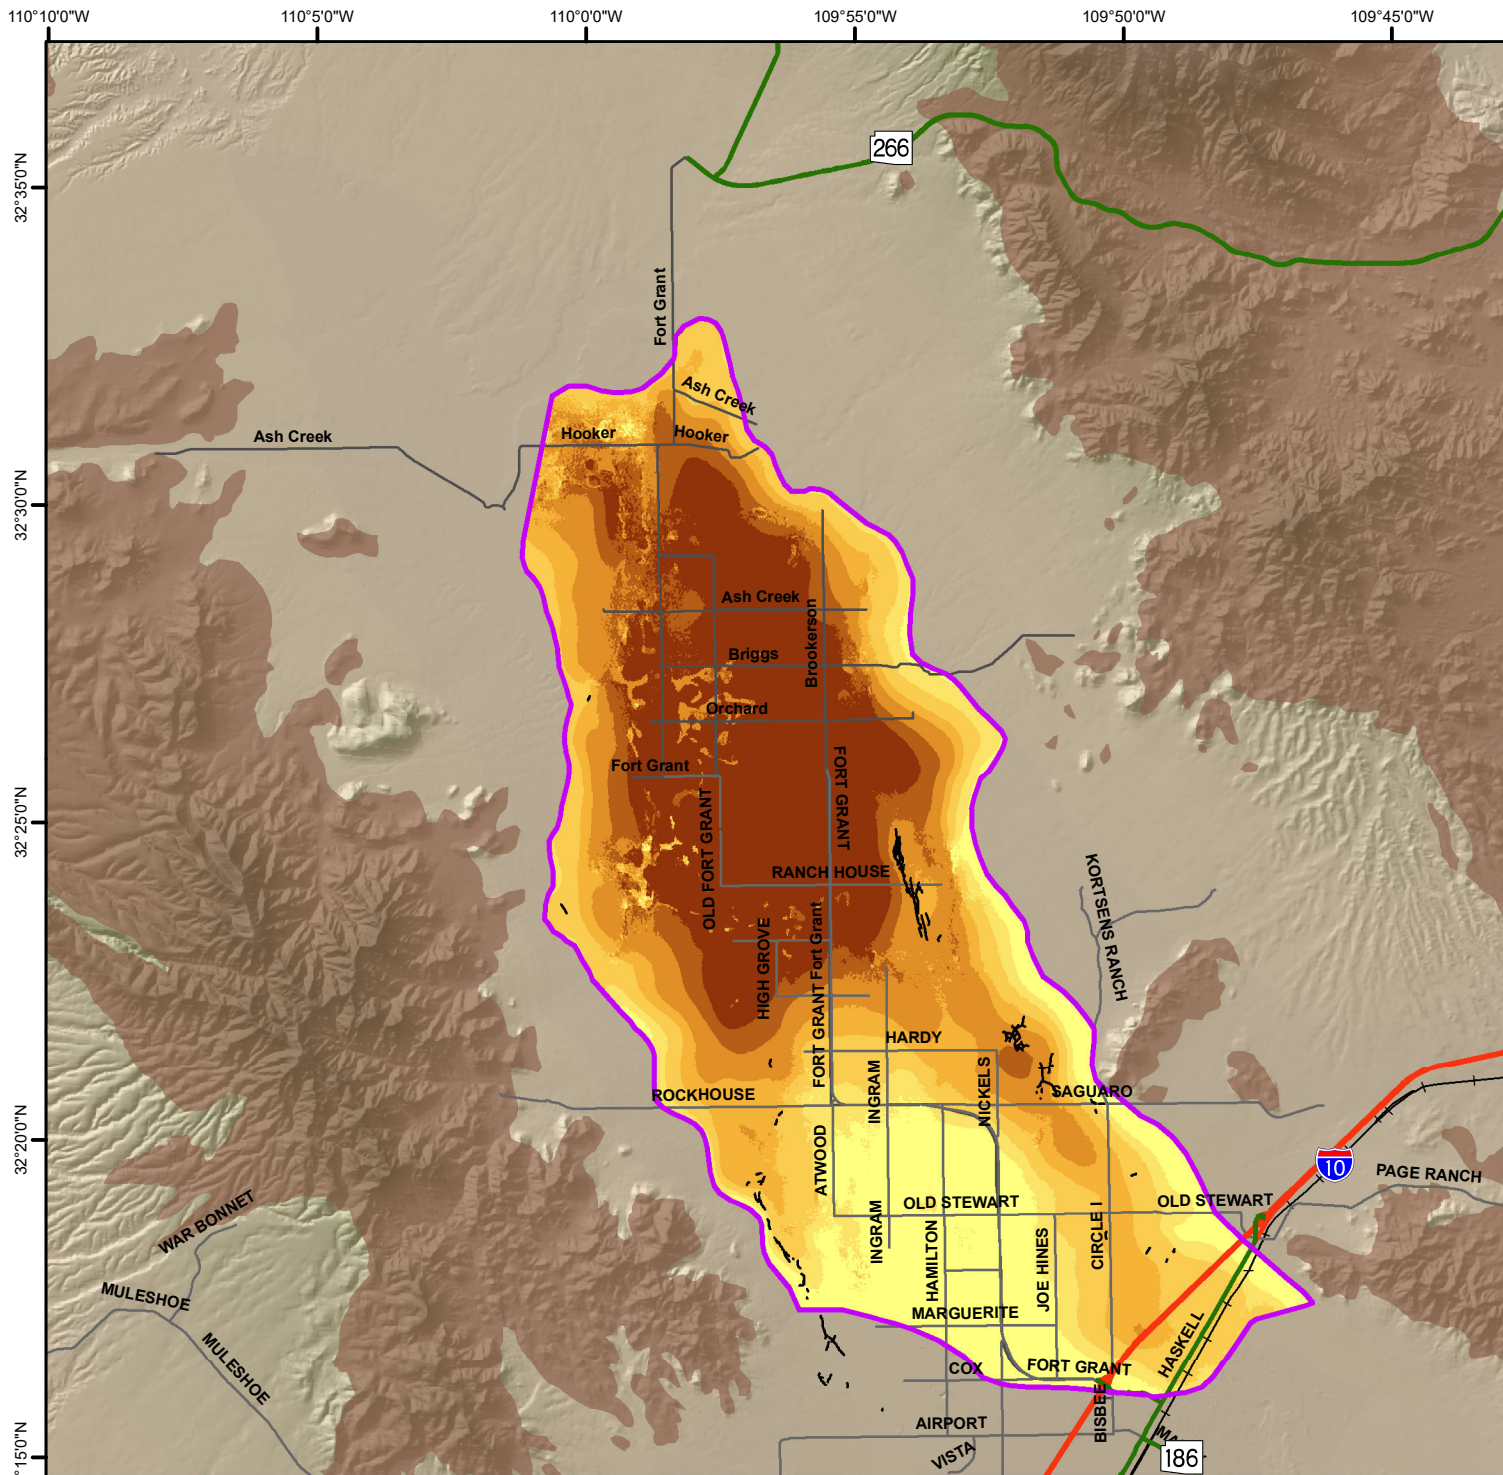
Decorrelation (white areas) are areas where the phase of the received satellite signal changed between satellite passes, causing the data to be unusable. This occurs in areas where the land surface has been disturbed (i.e. bodies of water, snow, agriculture areas, areas of development, etc).

Earth fissures were mapped by the Arizona Geological Survey.
For information on earth fissures visit: www.azgs.gov/EFC
